Successful NRW Reduction Experience in China

Keywords: NRW; China; Sino French Water

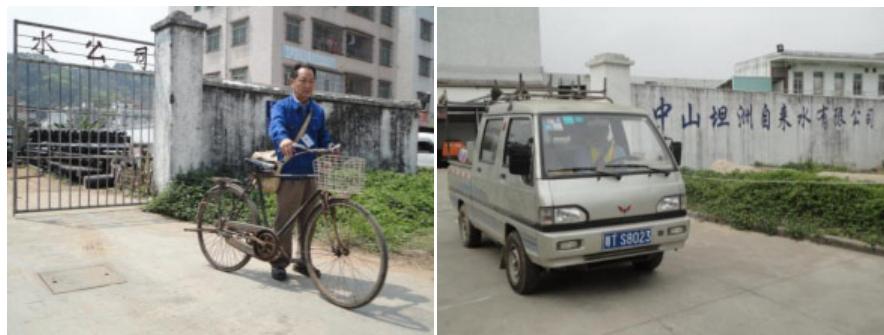
Figure 3 - Method of transportation of the repair team before and after

In the area of repairs, Tanzhou water did not need to start from scratch. There was already a repair team. The repair techniques of the team were to be improved, as well as their transportation means (see Figure 4). The average repair time was too long, between 4 to 8 hours. By reinforcing the size of the repair team, equipping them with the proper transportation vehicles, tools and equipment, the repair time was greatly reduced to an average of 2 to 4 hours.

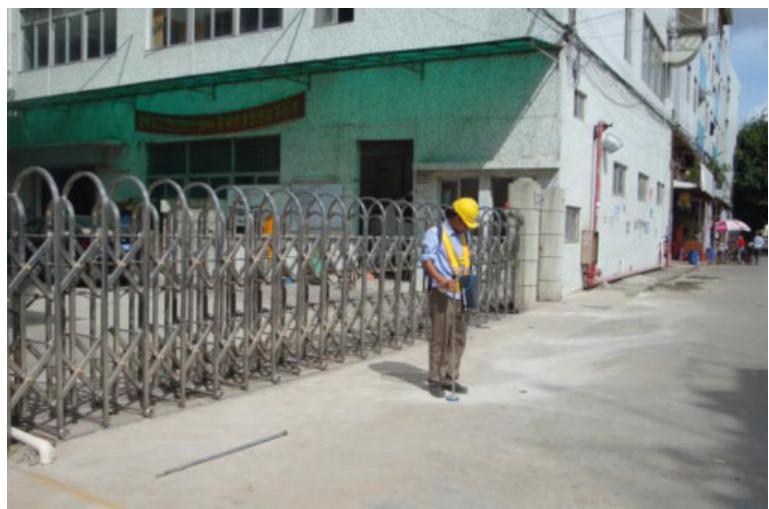
Figure 6 - Helium detection outside factory

In addition to acoustics leak detection equipment, Tanzhou Water also looked into new leak detection technology: helium, which was a new technology for the water industry in China. This was a portable helium leak detection unit developed within the Suez Environnement group.

In the past 2 years, with network expansion, Tanzhou Water has laid over 200km of PE pipes. The acoustic leak detection on non-metallic pipes was not very effective. So originally Tanzhou Water purchased the helium equipment for this purpose. However, since these pipes are new, they do not have many leaks, so now they use it on metallic network as well, particularly in areas where acoustic equipment doesn't work very well, such as noisy areas, industrial zones, and areas where the network is complicated and correlation is difficult. One notable example is outside a factory in Tanzhou where it was noisy 24-7. When Tanzhou Water leak detection team used acoustic leak detection equipment, both the old equipment and the new ones purchased in 2009, they only found dry holes. However, with the helium, they found 2 leaks on the pipe with precision within 1.5m.

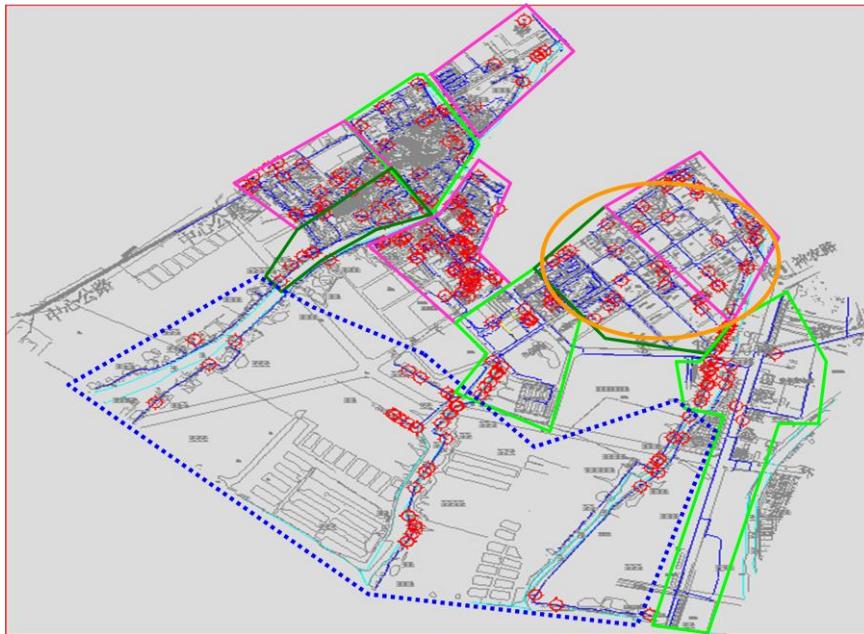
suitable leak detection equipment for each area. From the figure below, the solid polygonal pink and green areas are most suitable for noise loggers; the orange circular area is an industrial zone, which is suitable for helium gas; finally blue dotted area is suitable for geophone and listening sticks as there are not many valves on the pipe.

Figure 7 - Leak detection strategy of Tanzhou Water

With the addition of new equipment but needing to keep the same number of staff, Tanzhou Water needed to revise their leak detection plan to optimize their resources. Considering the network conditions, the leak detection team decided to use the most
